248 Division Ave
Massapequa, NY 11758
516-351-1661
FAX 516-799-8645

RE: 321 Any Street
Any Town, NY 22222

REPORT SUMMARY

Division Home Inspections, Inc

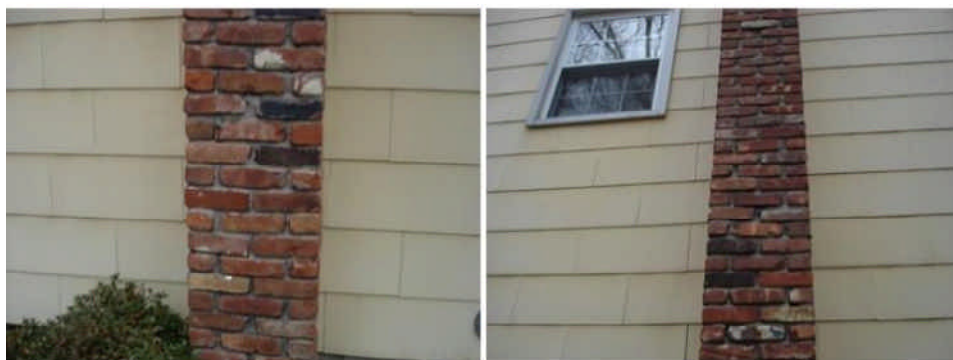
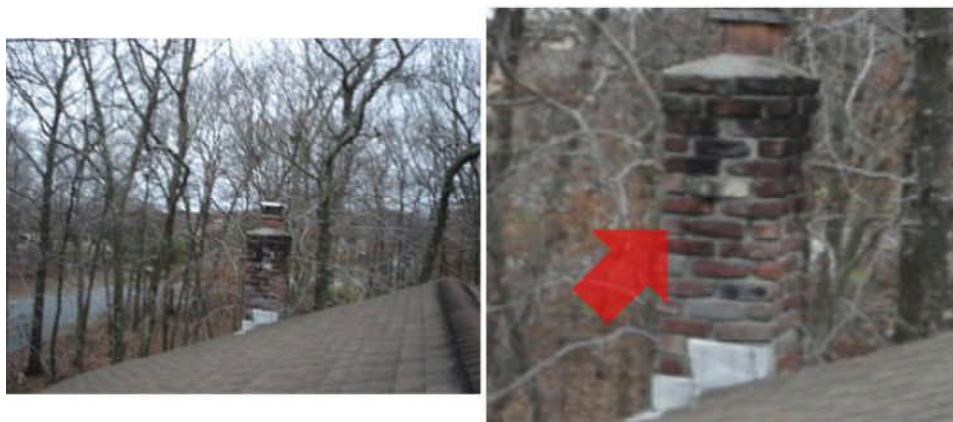
Deteriorating Mortar Joints
Brick.

Some of the mortar joints near the top of the chimney are beginning to deteriorate. Future re-pointing may be required.

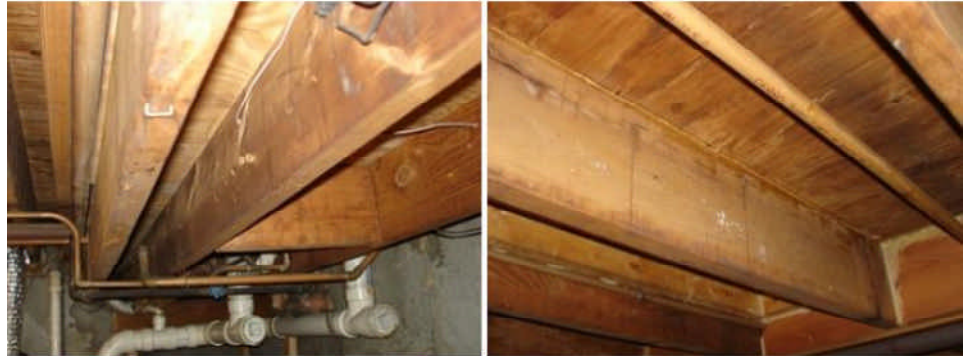
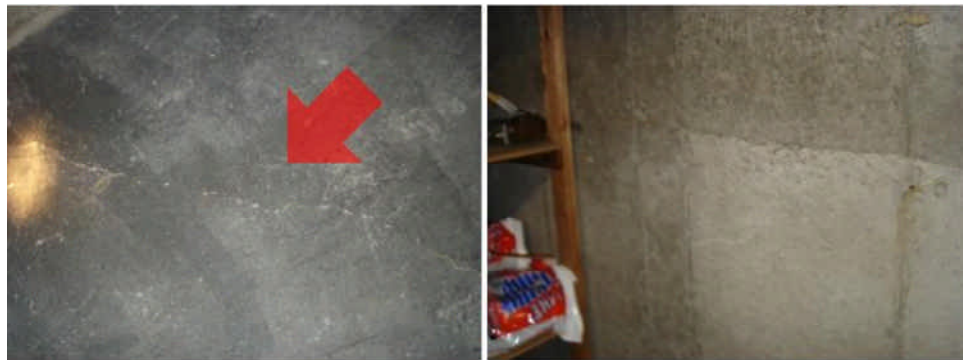
Minor Floor Crack

There is a minor crack in the floor near the bottom of the basement stairs. This crack appears to be insignificant at this time. Recommend continued monitoring.

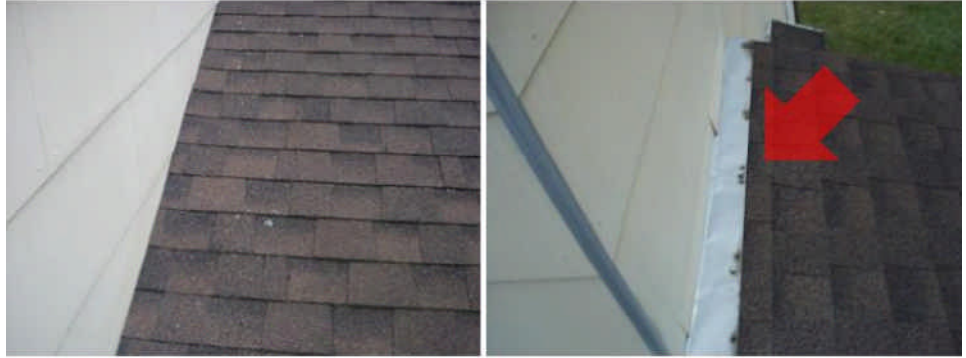
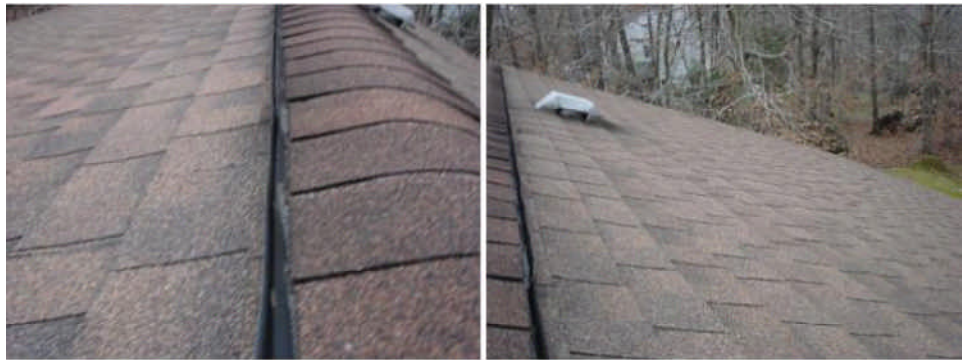
Exposed Nail Heads
Composition shingles.

The roof appears to be 5 to 7 years old and within its useful life. There is some moss/mildew buildup on the lower front roof, also on the garage roof. Moss and mildew buildup is a result of moisture that does not completely dry. This is usually prevalent in areas of the roof that are not fully exposed to the sun. Recommend brushing off with soft bristle brush and washing down with hose. Also, consider trimming trees back that may be blocking sunlight. Exposed nail heads are visible in several areas of the roof surface. Exposed nail heads rust and deteriorate after time and the head falls off. Nails protrude the roof surface and terminate inside the attic. When the nail head falls off, leaks will start and the roof will start to deteriorate. Small dabs of roofing tar or roofing cement over the exposed nail head will prevent this from occurring.

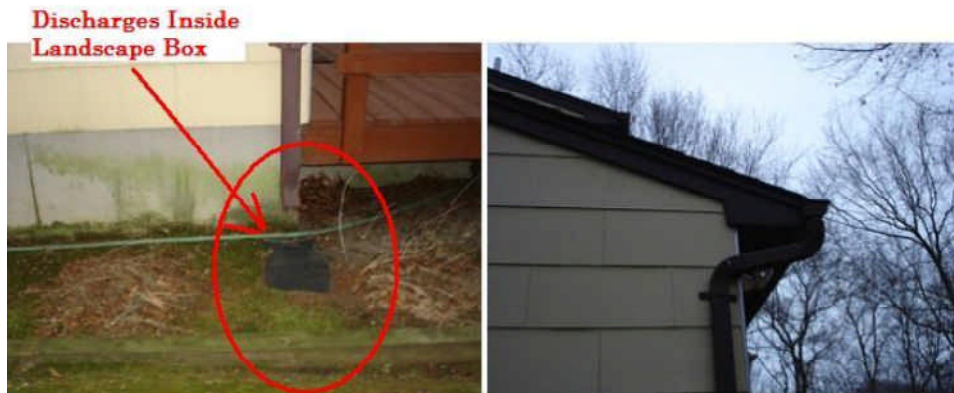
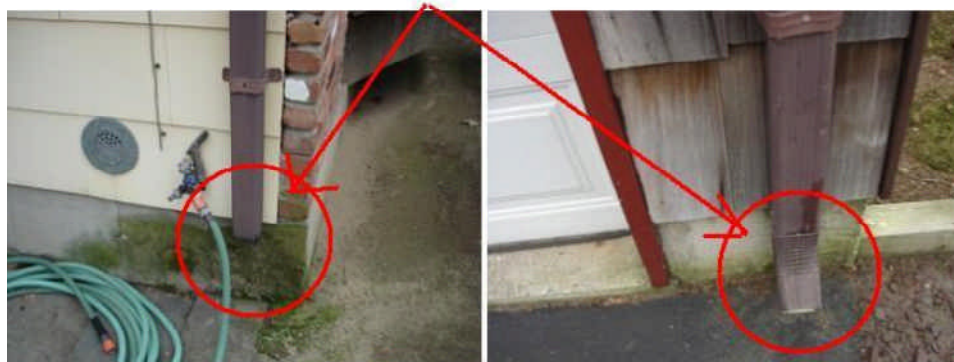
Extend Downspouts

Missing downspout elbow on one downspout. Route downspouts away from the building
 Leaders and gutters are designed to direct water away from the building to prevent moisture from penetrating the foundation and basement. Maintenance of gutters is critical to keeping a basement and crawl space dry. Remove debris periodically, more often when overhanging trees and brush are present. Extend downspouts away from building with downspout extenders. Consider installation of gutter (leaf) guards to prevent debris build up.

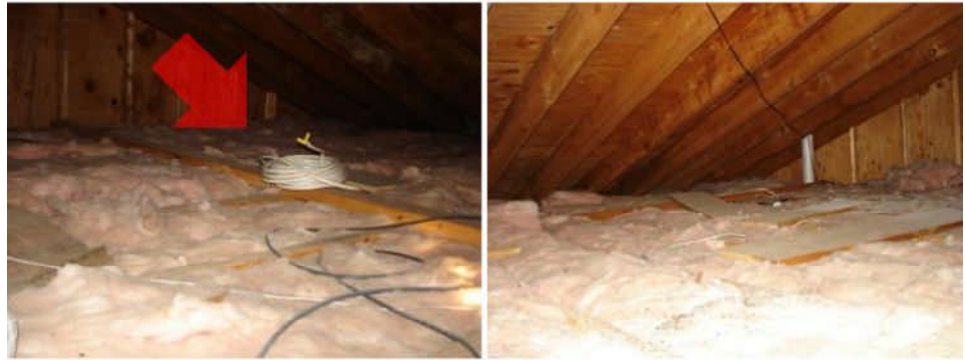
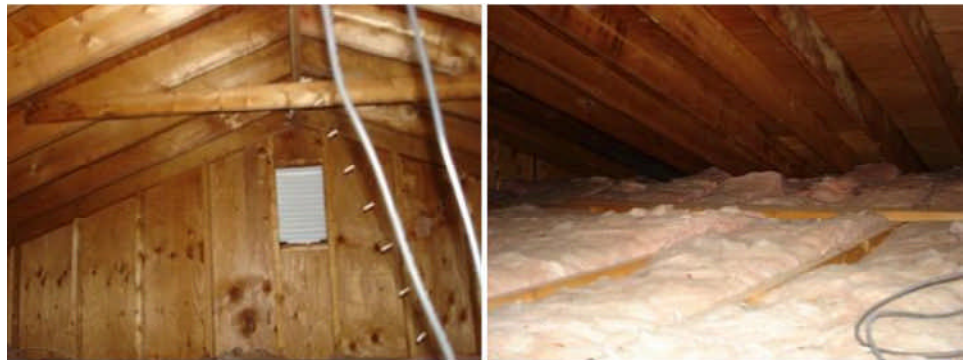
Coiled up Roll of Romex

The main attic, accessible through a bedroom closet, has no walk boards. There is a coiled up roll of electrical wire, (Rom.ex), with wire nuts on the hot and neutral. It was not determined if this coil was live. The attic is ventilated with a ridge vent, soffit vents and louvered vents in the peak. Ventilation is adequate.

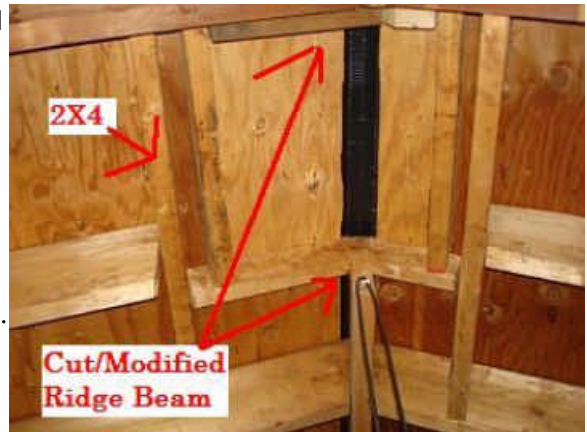
The ridge has been modified and altered. The reason for this alteration is not apparent. The ridge beam has been cut at approximately the center of the roof and haphazardly boxed out with headers. One of the headers is made of a 2" x 4', the other a 2" x 8". These headers are not doubled. The joints are open and sloppy and do not appear professionally done. Recommend further evaluation by structural engineer and repair by licensed framing contractor.

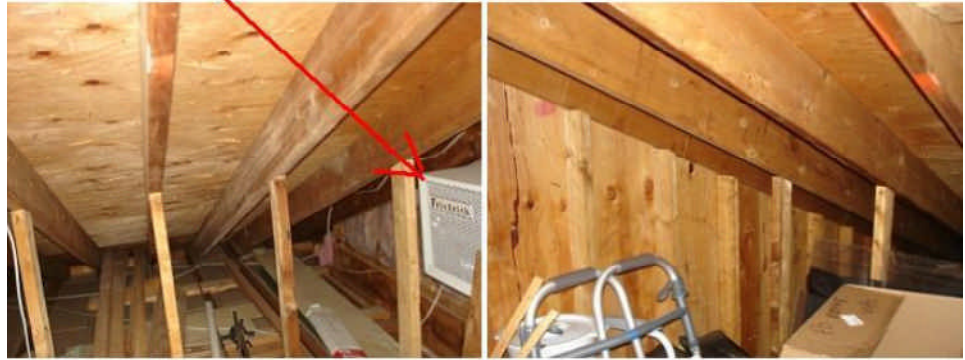
GARAGE ATTIC:**Bedroom Air Conditioner**

The garage attic does have walk/floor boards and provides storage. There are several electrical wires that are run together on the attic floor, within the storage space. Wires lying loose on an attic floor is acceptable as long as the space is not used for storage. This space is being used for storage. Recommend securing wiring every six feet and either hanging overhead or covering with a protective material to prevent damage. There is a wall air conditioner for a bedroom that is installed into the garage attic. This is not a desired application as air conditioning removes humidity and moisture from the room and dispels it to the exterior. In this case, the moisture and humidity will be discharging to the garage attic. Recommend relocating the air conditioner to an exterior wall.

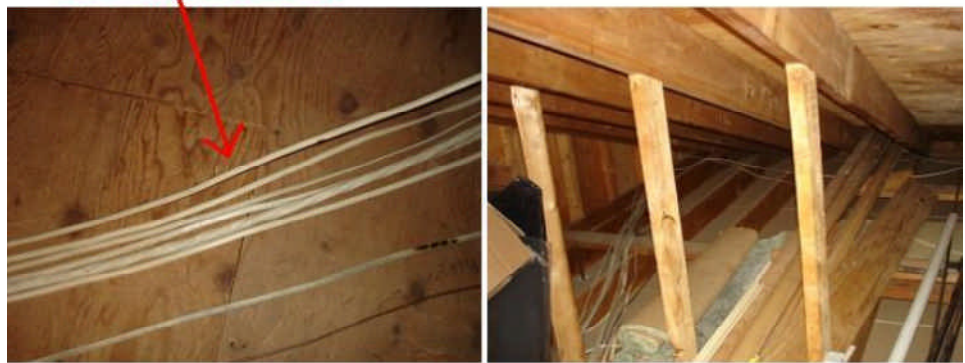
**Cabeling On Attic Floor**

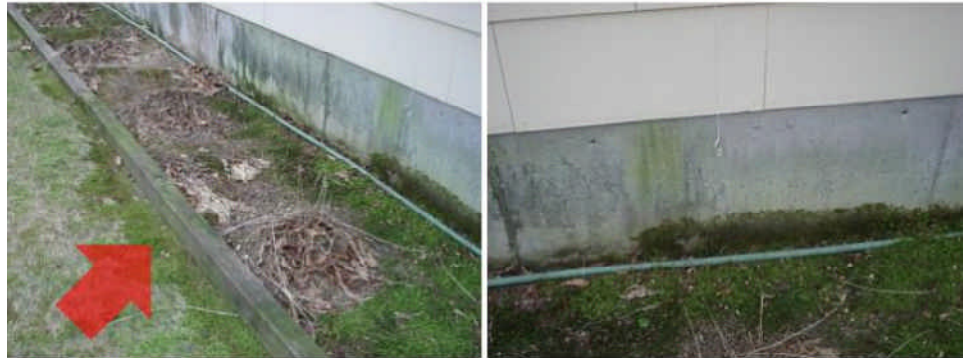
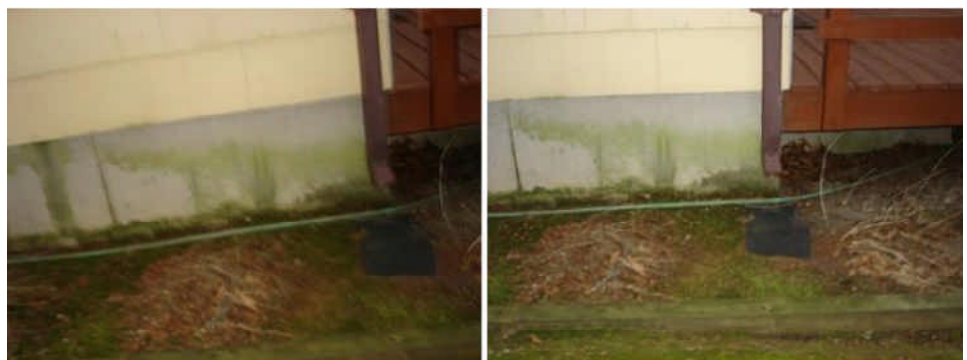
Landscape Box

Grade appears acceptable in most areas, however, at the garage side there is a landscape box, with a gutter that drains inside. Landscape boxes act as a dam and can allow water to puddle or pool at the foundation. Recommend removal of wooden ties and extending downspouts.

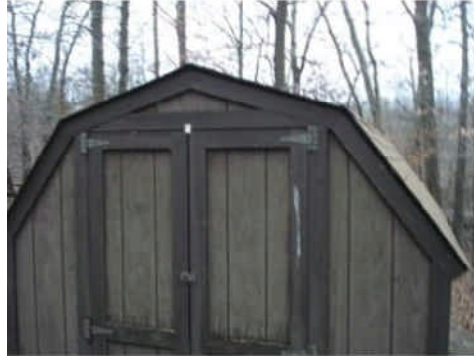
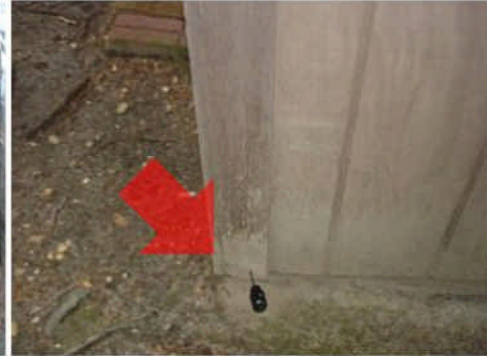
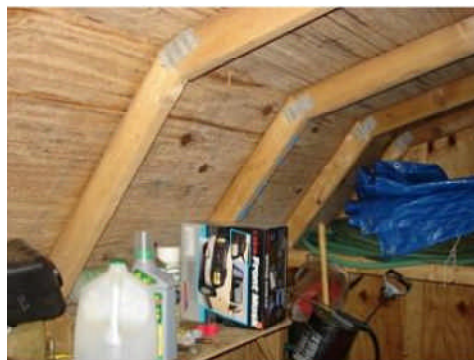
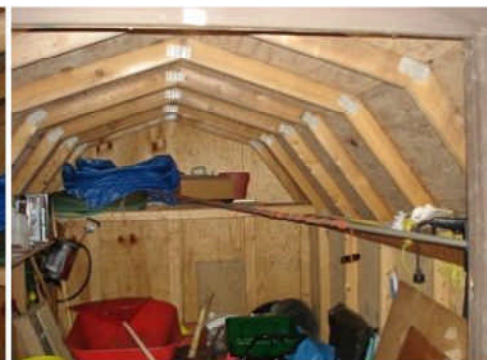
Deterioration

The siding is beginning to deteriorate at the bottom of the shed.

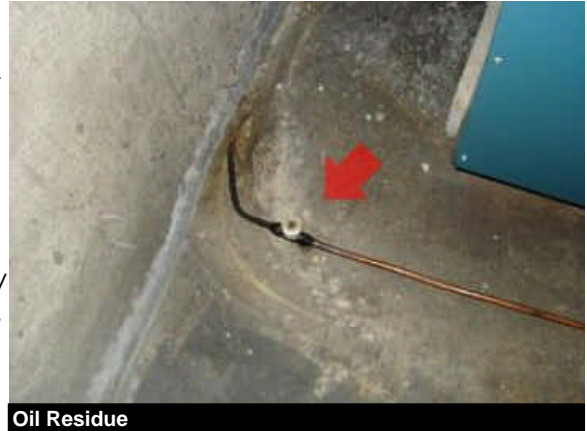
GENERAL SUGGESTIONS: The oil feed line from the tank to the oil burner has some oil residue at and near the valve. There may be a slight leak. Recommend repair. There is a slight smell of oil when the boiler ignites. The cause was not definitely determined, however, it may be from poor fuel to air ratio. Suggest having unit serviced, cleaned and tuned up, prior to this and all heating seasons.

**Oil Residue**

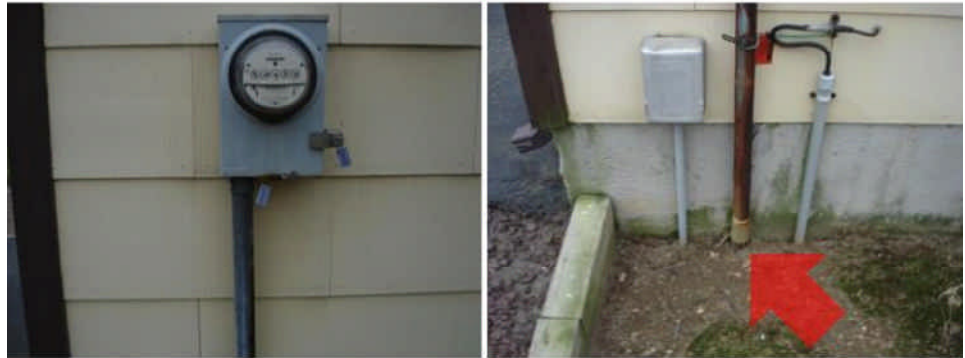
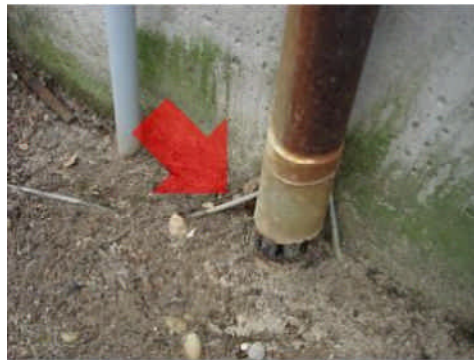
Service Lateral Conduit Deteriorated

Copper. Electric service enters the house below grade. We recommend having a licensed electrician inspect wiring and splice box below grade. The service lateral conduit is deteriorated at grade, where the service cables come out of the ground. The conduit has a large hole and can allow debris and water to enter and can lead to deterioration of the cables. Recommend contacting the electric company, (LIPA), and/or a licensed electrician for further evaluation and repair.

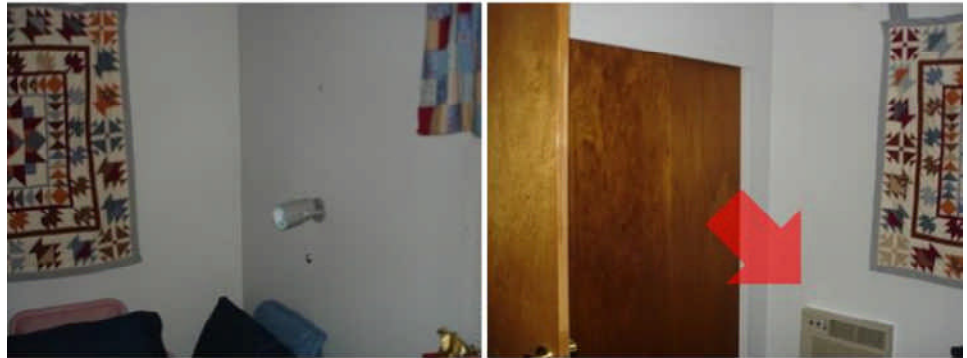
Air Conditioner In Garage Attic

SMOKE ALARM- The National Fire Protection Association recommends smoke alarms be installed within 15 feet of all bedroom entry doors. The air conditioner for this room is vented to the garage attic. (See garage attic)
