248 Division Ave
Massapequa, NY 11758
516-351-1661
FAX 516-799-8645

RE: 321 Any Street
Any Town, NY 22222

REPORT SUMMARY

Division Home Inspections, Inc

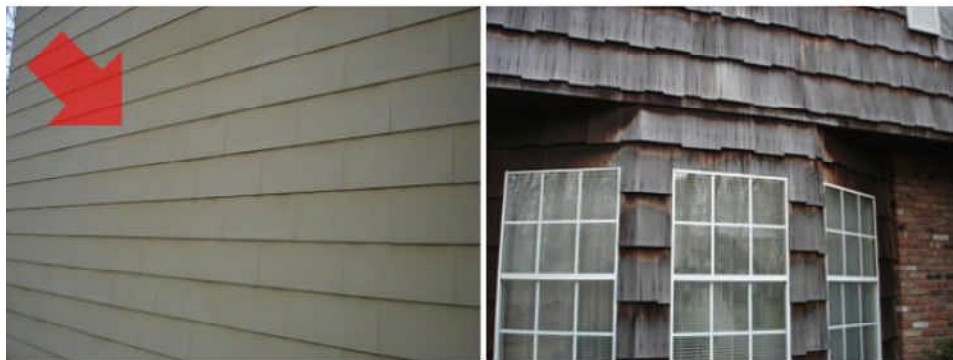
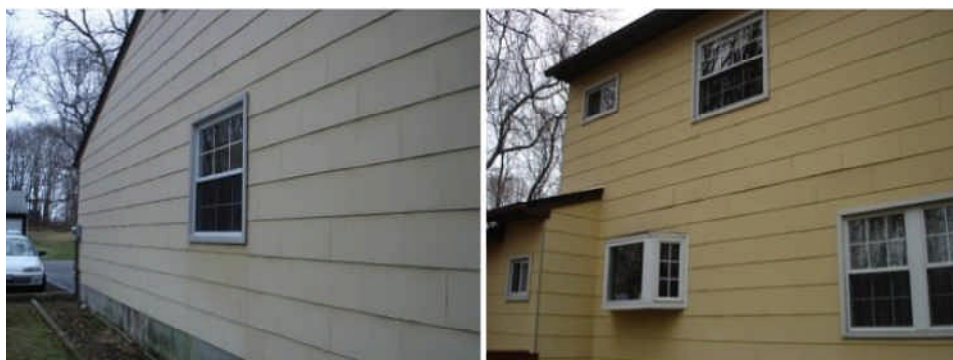
Composite Shingles

Wood siding, Brick, Shingles.

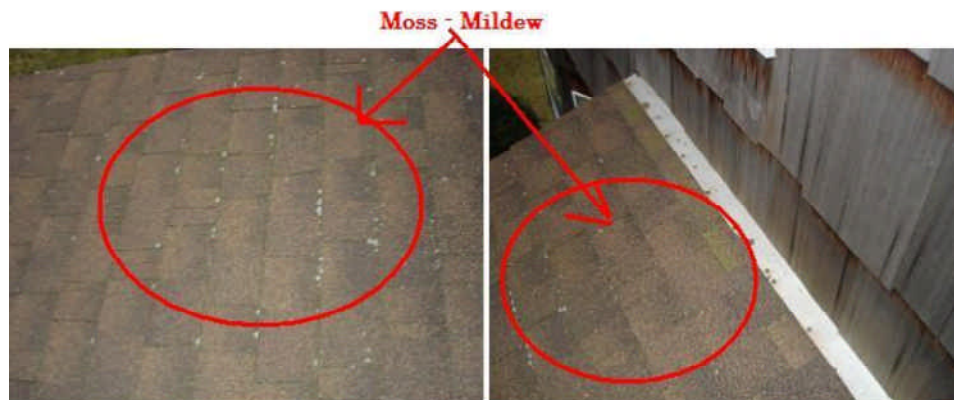
Exposed Nail Heads
Composition shingles.

There is some moss/mildew buildup on the lower front roof, also on the garage roof. Moss and mildew buildup is a result of moisture that does not completely dry. This is usually prevalent in areas of the roof that are not fully exposed to the sun. Recommend brushing off with soft bristle brush and washing down with hose. Also, consider trimming trees back that may be blocking sunlight. Exposed nail heads are visible in several areas of the roof surface. Exposed nail heads rust and deteriorate after time and the head falls off. Nails protrude the roof surface and terminate inside the attic. When the nail head falls off, leaks will start and the roof will start to deteriorate. Small dabs of roofing tar or roofing cement over the exposed nail head will prevent this from occurring.

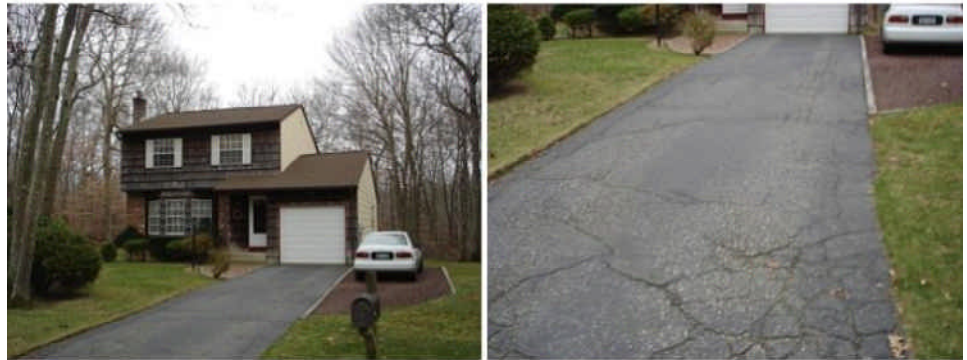
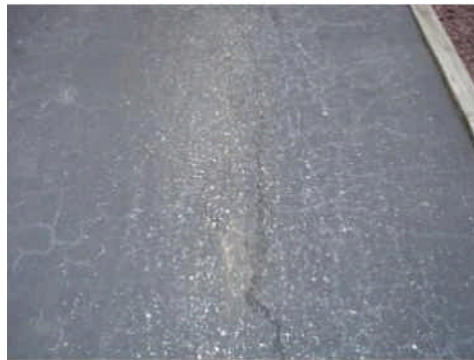
Paved Asphalt.

The driveway has some typical cracking and dips. Appears serviceable.

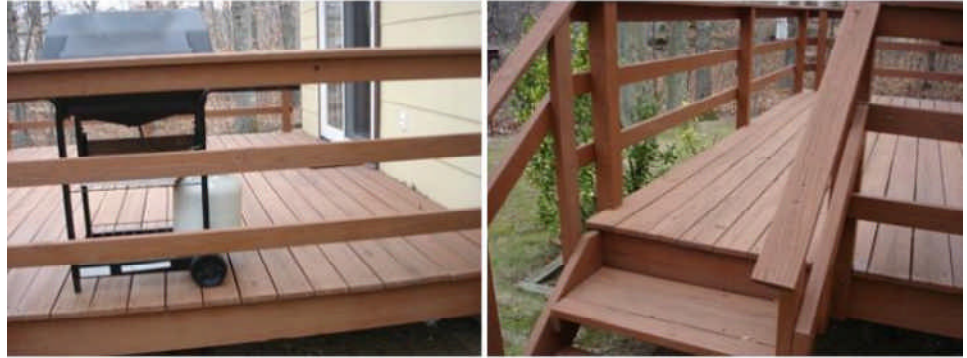
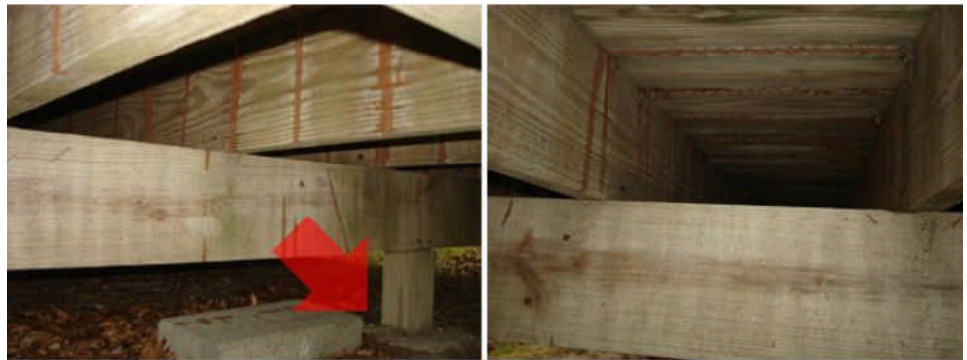
Concrete Pier

Wood.

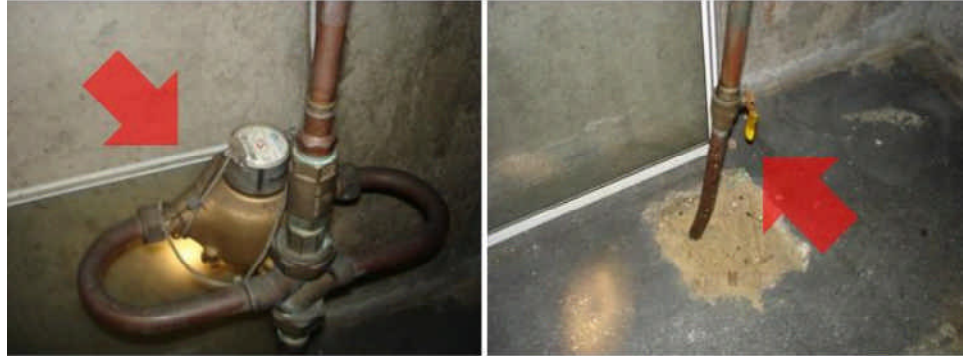
Water Meter - Main Water Shut Off

Copper.

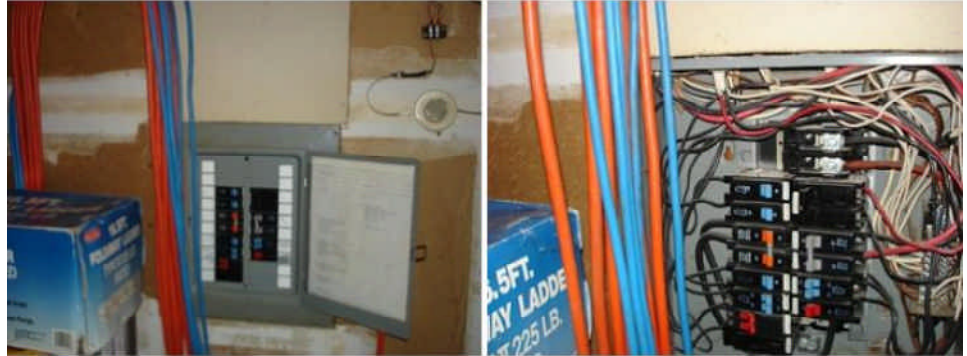
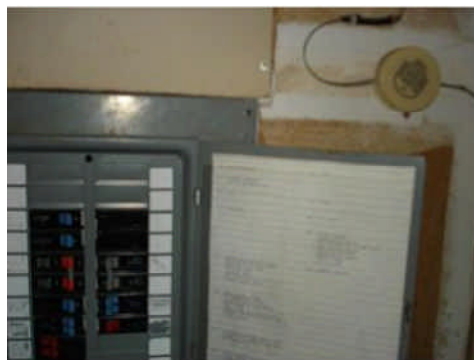
Garage.

Circuit and wire sizing correct so far as visible, Grounding system is present. Service is 100 AMP. A service disconnect was not found. The service panel has six or more breakers, therefore a service disconnect/main breaker is required. Have a licensed electrician make further evaluation and corrections as needed.

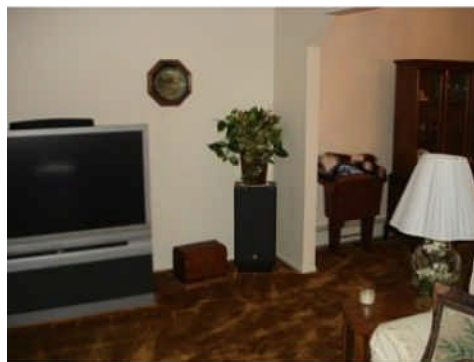
LIVING ROOM:

Good overall condition.

Walls: Good overall condition.
Ceilings: Good overall condition.
Floors: Viewing of floor surfaces was restricted due to carpeting.
Windows: Fair overall condition.
Electrical: OUTLETS- Good overall condition, SWITCHES- Good overall condition.

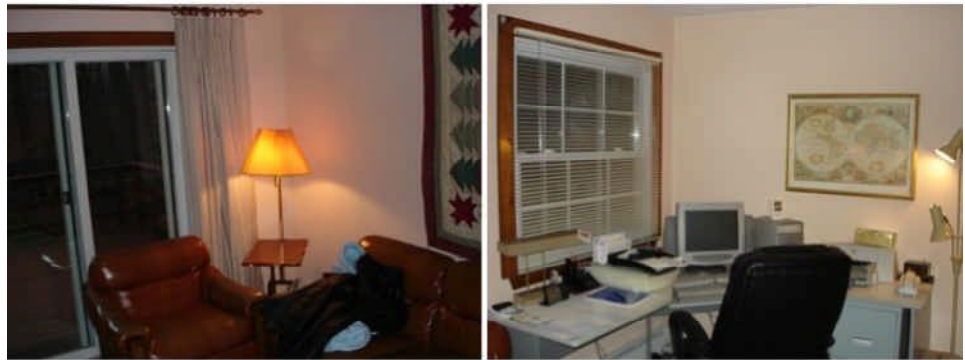
FAMILY ROOM / OFFICE:

Walls: Good overall condition.
Ceilings: Good overall condition.
Floors: Viewing of floor surfaces was restricted due to carpeting.
Doors: Good overall condition.
Electrical: OUTLETS- Good overall condition, SWITCHES- Good overall condition.

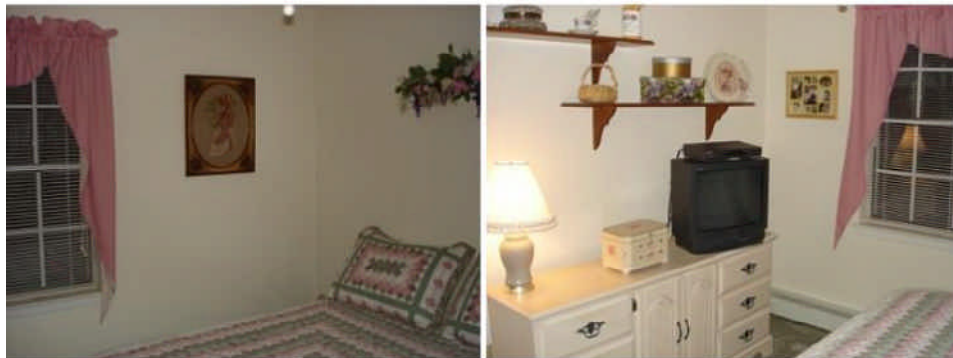
BEDROOM # 1:

Good overall condition.

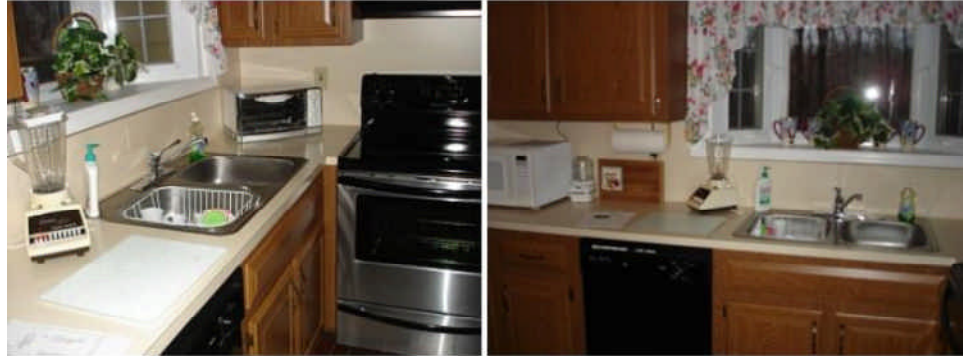
KITCHEN

Good Overall.

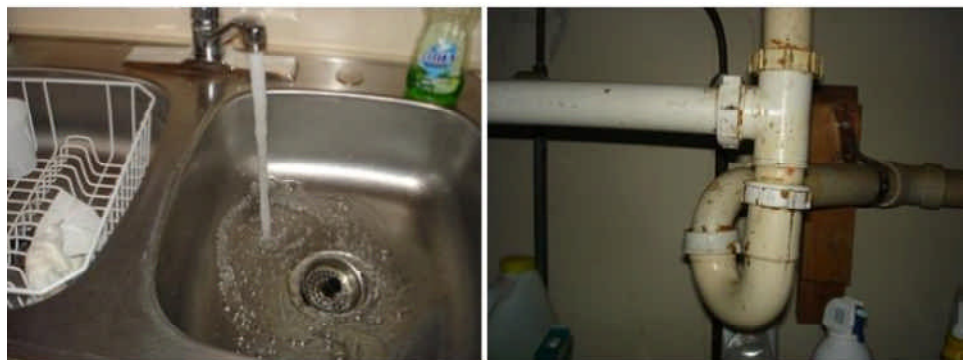
KITCHEN SINK:

Stainless Steel, Appears serviceable, Drain appears serviceable.

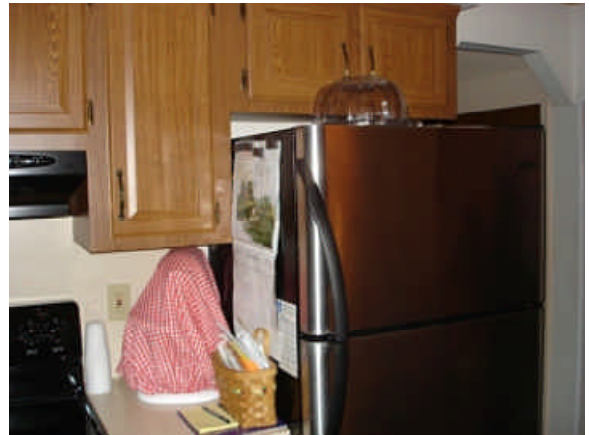
REFRIGERATOR:

TYPE AND CONDITION: Fair Overall.

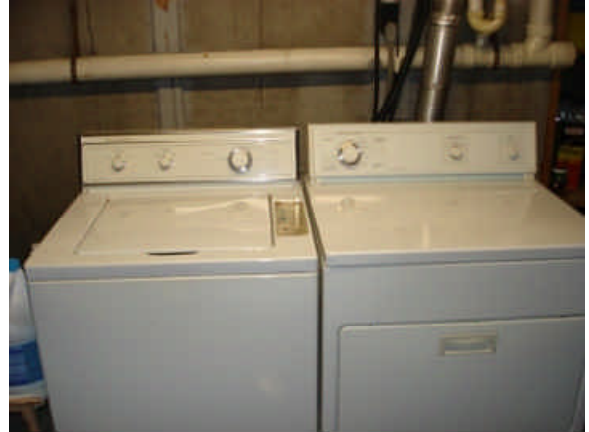
LAUNDRY :

CONDITION: Plumbing appears serviceable, 220 Service-operational, Dryer venting is provided.

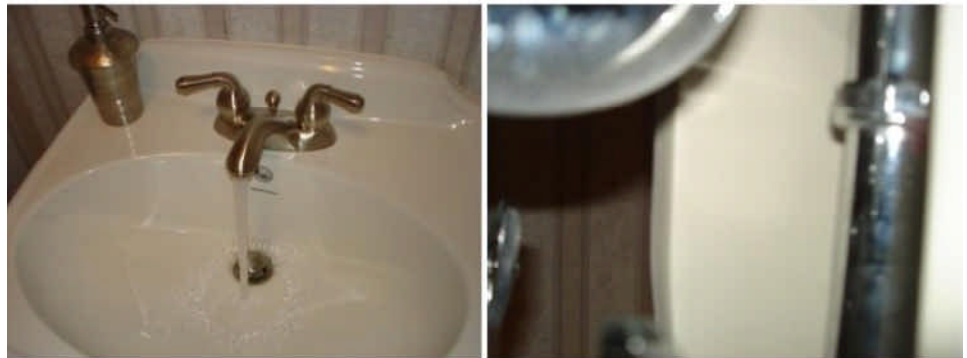
CONDITION OF SINK:

Appears serviceable, Drain appear serviceable.

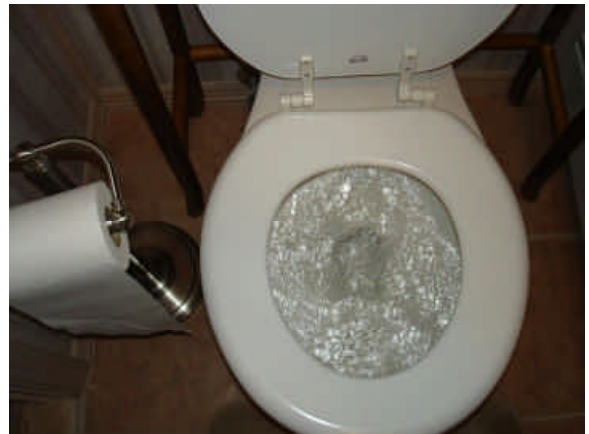
CONDITION OF TOILET:

Appears serviceable.

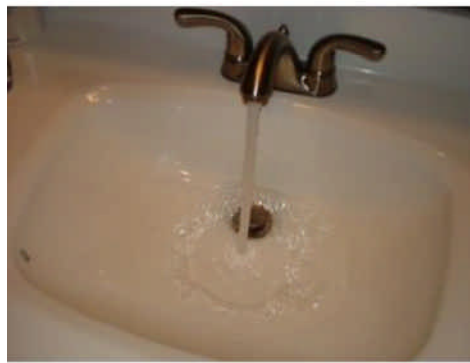
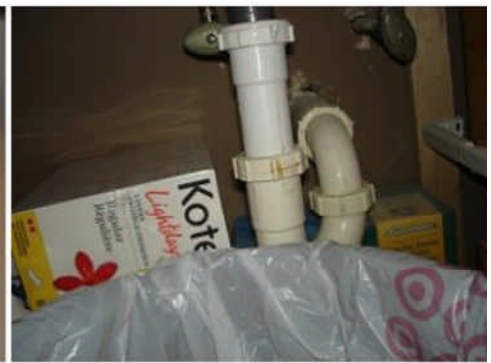
CONDITION OF SINK:

Appears serviceable, Drain appear serviceable.

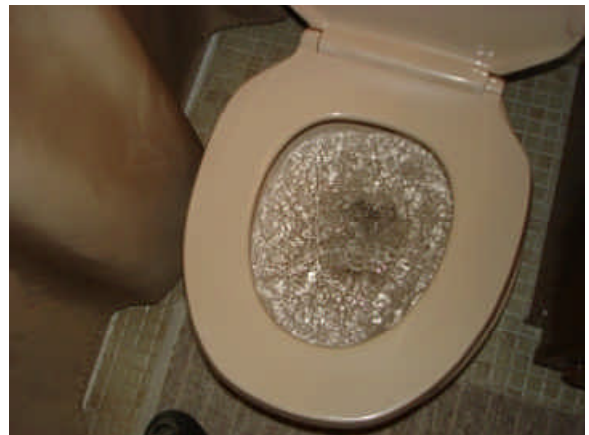
CONDITION OF TOILET:

Appears serviceable.

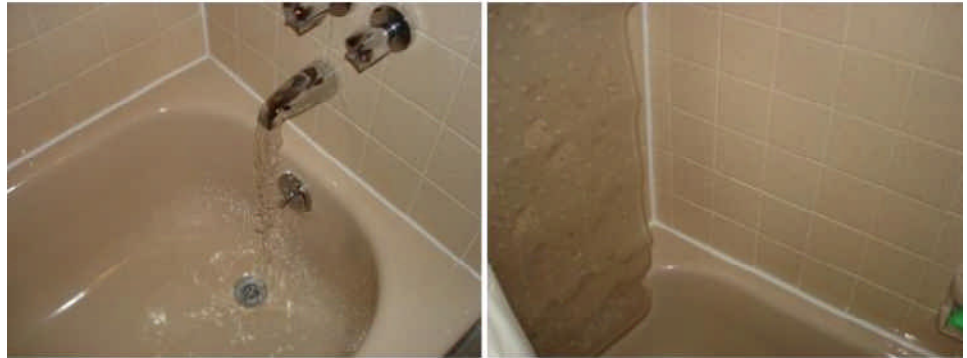
**TUB/SHOWER PLUMBING
FIXTURES:**

Appears serviceable, Drain appears serviceable.
